# UNDERWATER BRIDGE INSPECTION REPORT

STRUCTURE NO. 27510

ARCOLA CHANNEL

MINNESOTA DEPARTMENT OF TRANSPORTATION  
UNDERWATER BRIDGE INSPECTION

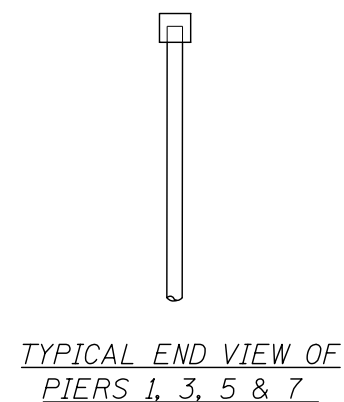
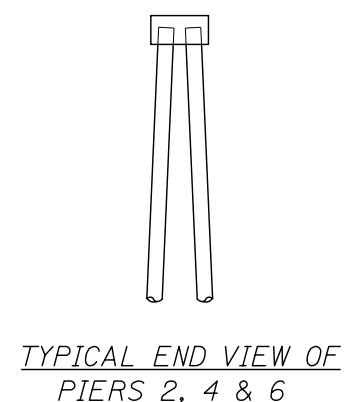
- 6 Abandoned concrete piers were encountered near Piers 2, 5, and 7 and extended approximately 1 foot above the waterline.
- 7 The steel pipe pile casings typically exhibited light to moderate surface corrosion with minor pitting with rust scale delaminations up to 1/8 inch thick from 1 to 1.5 foot above to 1 foot below the waterline.

- 8 The steel pipe pile casing exhibited a dent 3 feet above the waterline that was 8 inches in diameter with 1/2 inch of penetration. A second 12 inch diameter dent was observed at 2 feet below the waterline, with 5 inches of penetration.

- 9 The concrete pile cap exhibited areas of section loss approximately 1.5 feet long and 6 inches high on the west end with exposed reinforcing steel on the top and bottom edges. 2 to 3 inch penetration and wide spread cracking with rust staining.

- 10 The concrete repair to the pile cap at the east end of Pier 3 exhibited a crack extending from the top to the bottom of the pile cap on the south face.
- 11 Minor cracking at Northwest end and heavy cracking at Southeast end of pier cap at Piers 6 and 2.
- 12 The piles exhibited lighter corrosion and/or coating failure from channel bottom to 6 feet above waterline.
- 13 The pier cap at Bent 5 has exposed reinforcing steel at Southeast end on the South side.
